Mousam Lake Watershed Protection Project

York County Soil and Watershed Conservation District

April 13, 2022

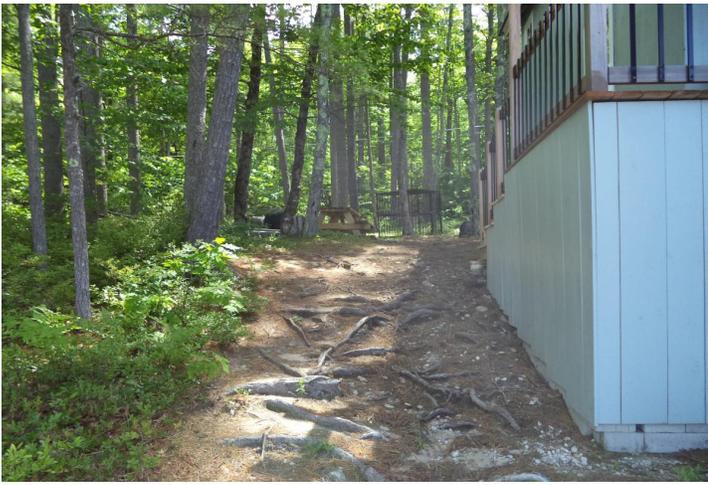
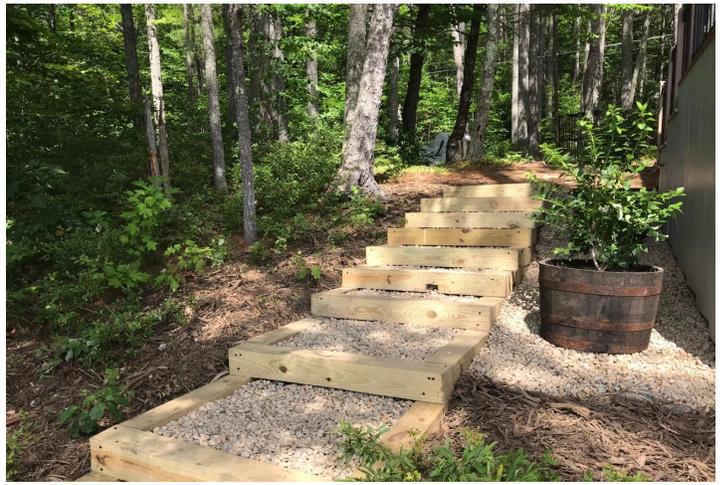
Before (left) and after (right) installation of infiltration steps

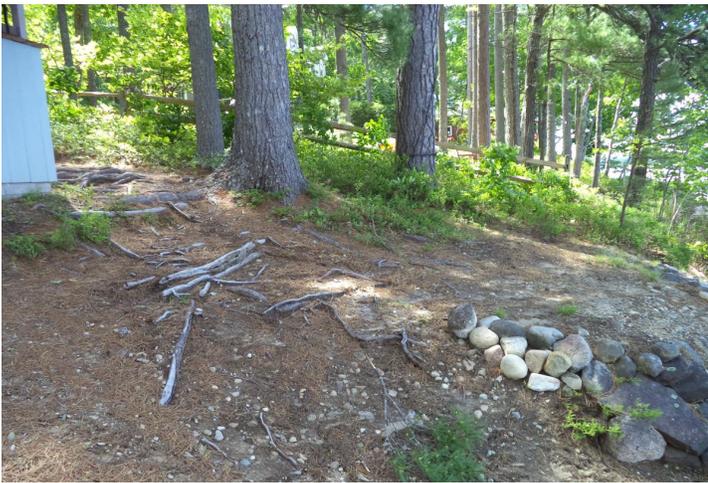
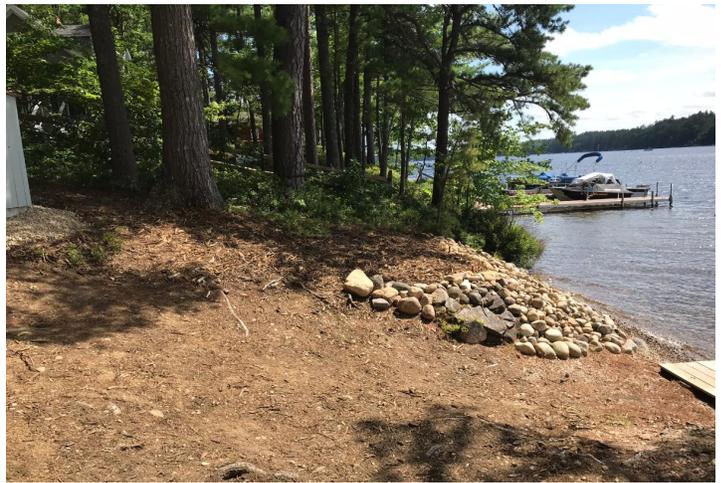
Before (left) and after (right) installation of conservation mulch

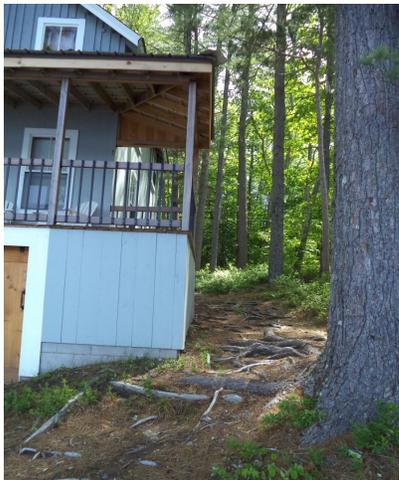
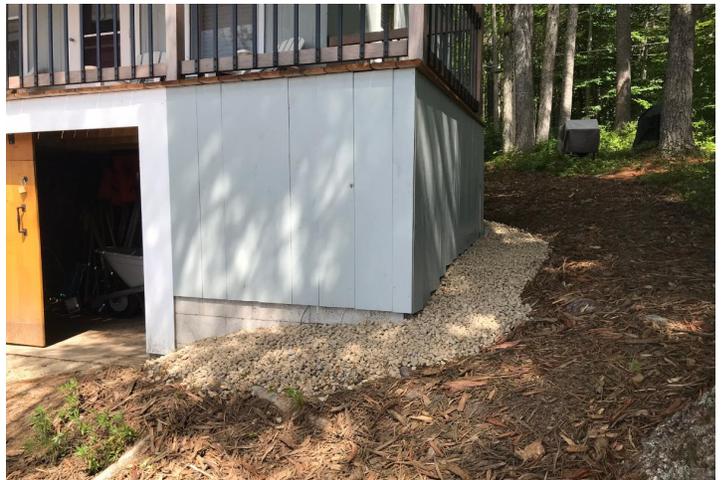
Before (left) and after (right) installation of conservation mulch and roof dripline infiltration trench

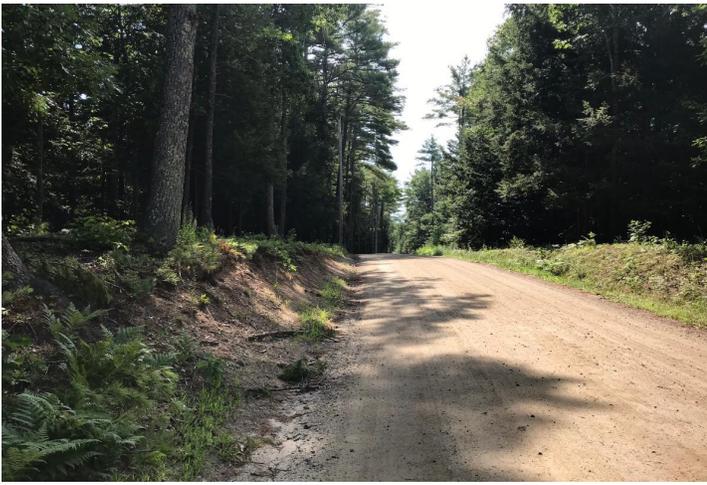
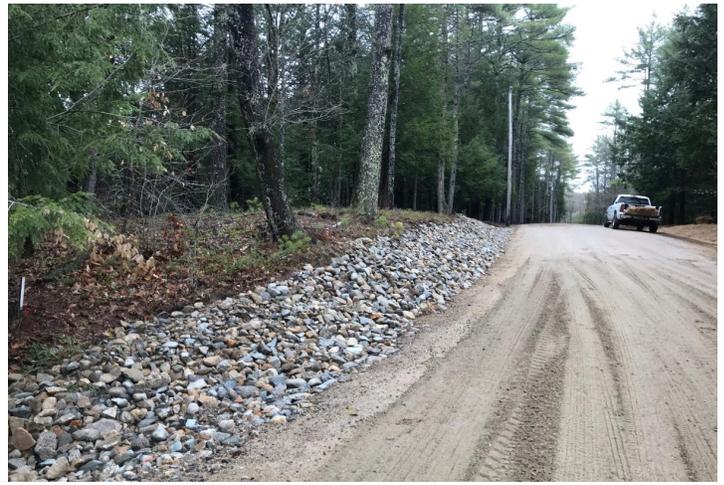
Before (left) and after (right) installation of riprap to stabilize embankment and capture sediment

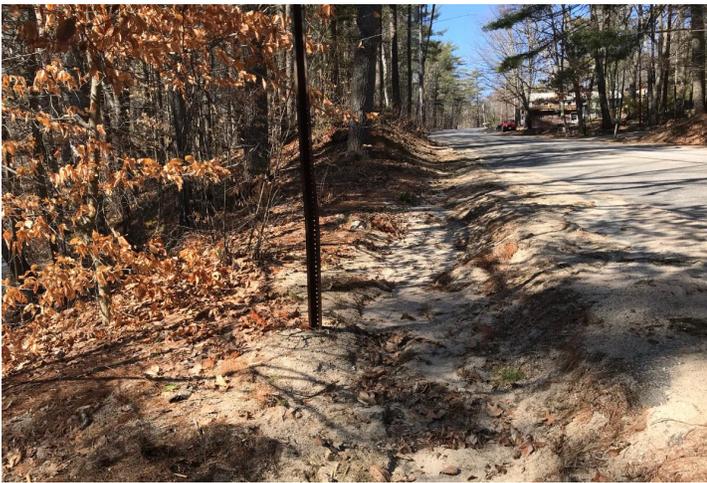
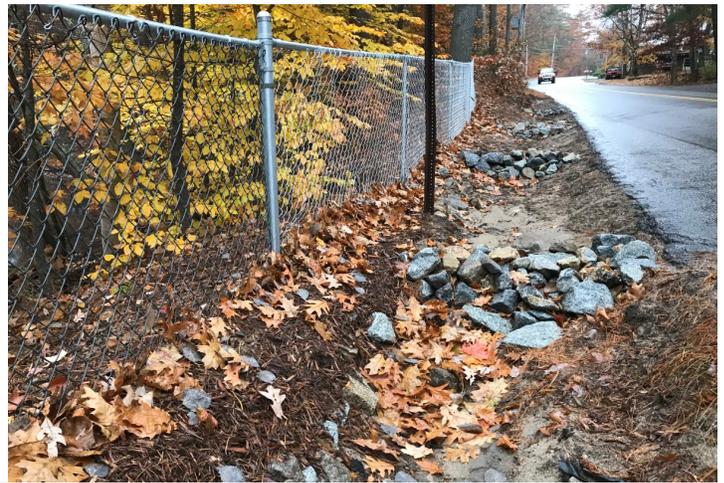
Before (left) and after (right) installation of stone check dams to capture sediment

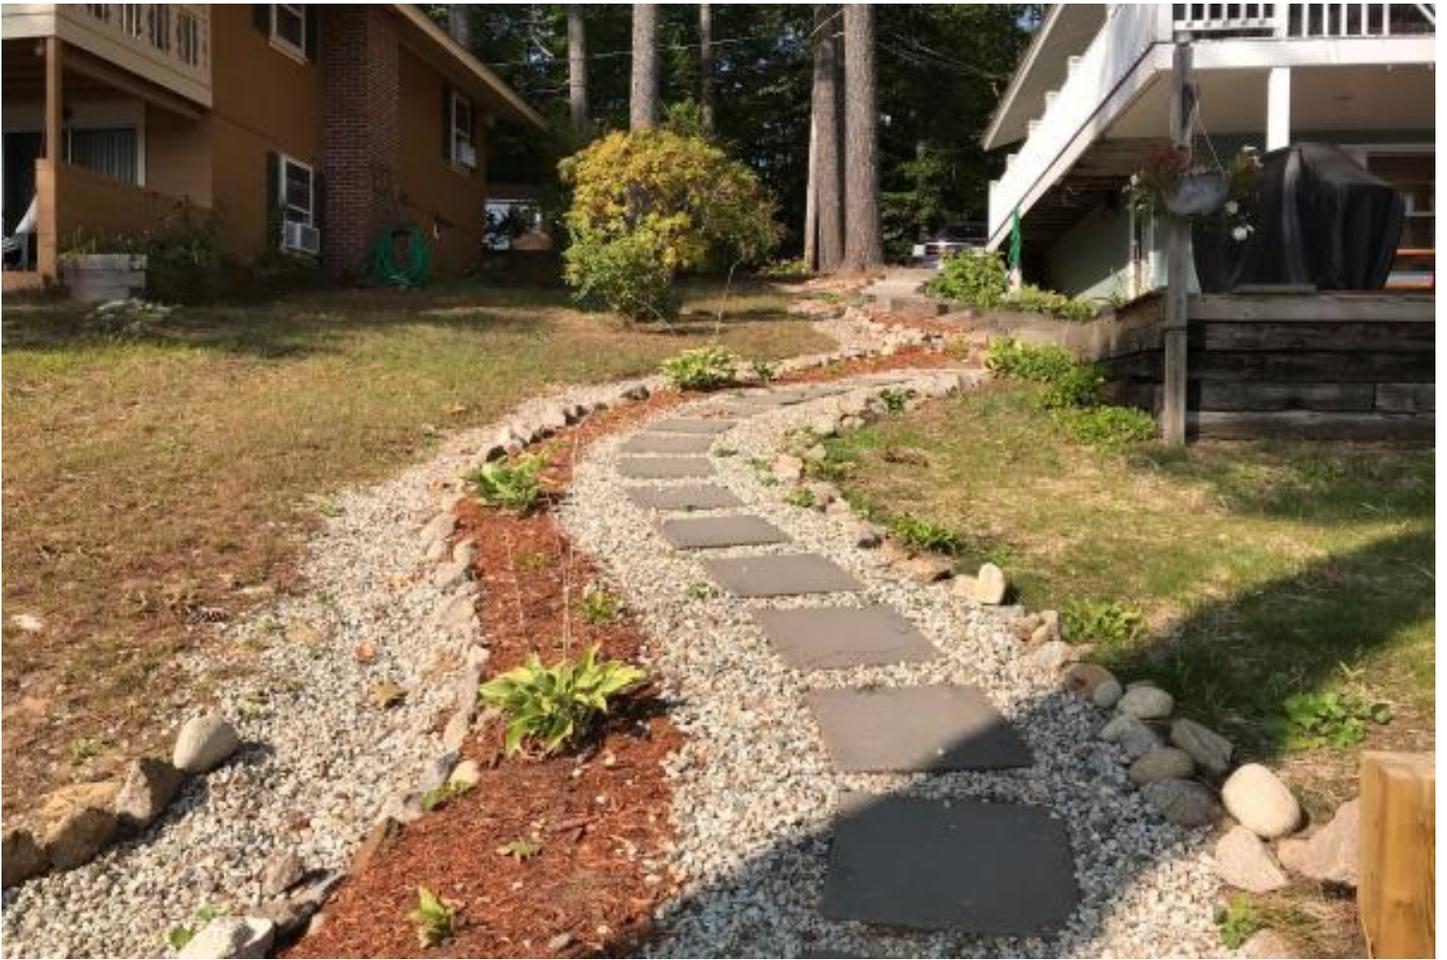
A winding path helps prevent stormwater from channeling and causing erosion. In addition, the crushed stone, mulch, and plants allow the stormwater to infiltrate into the ground.

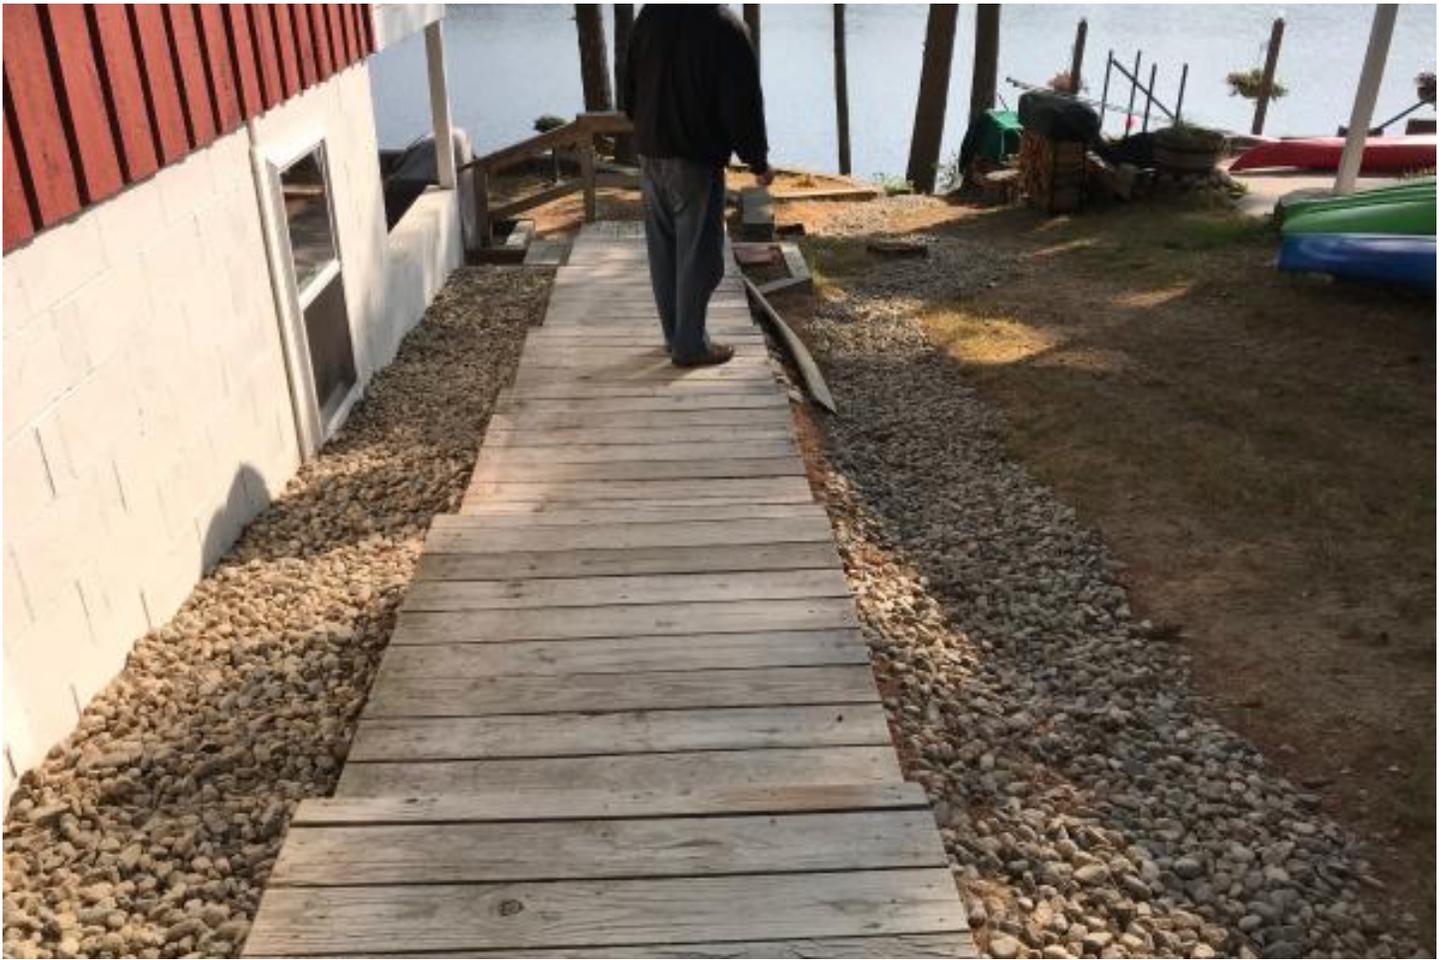
These crushed stone infiltration trenches allow roof runoff and stormwater to infiltrate into the ground and filter out pollutants before the water enters Mousam Lake.

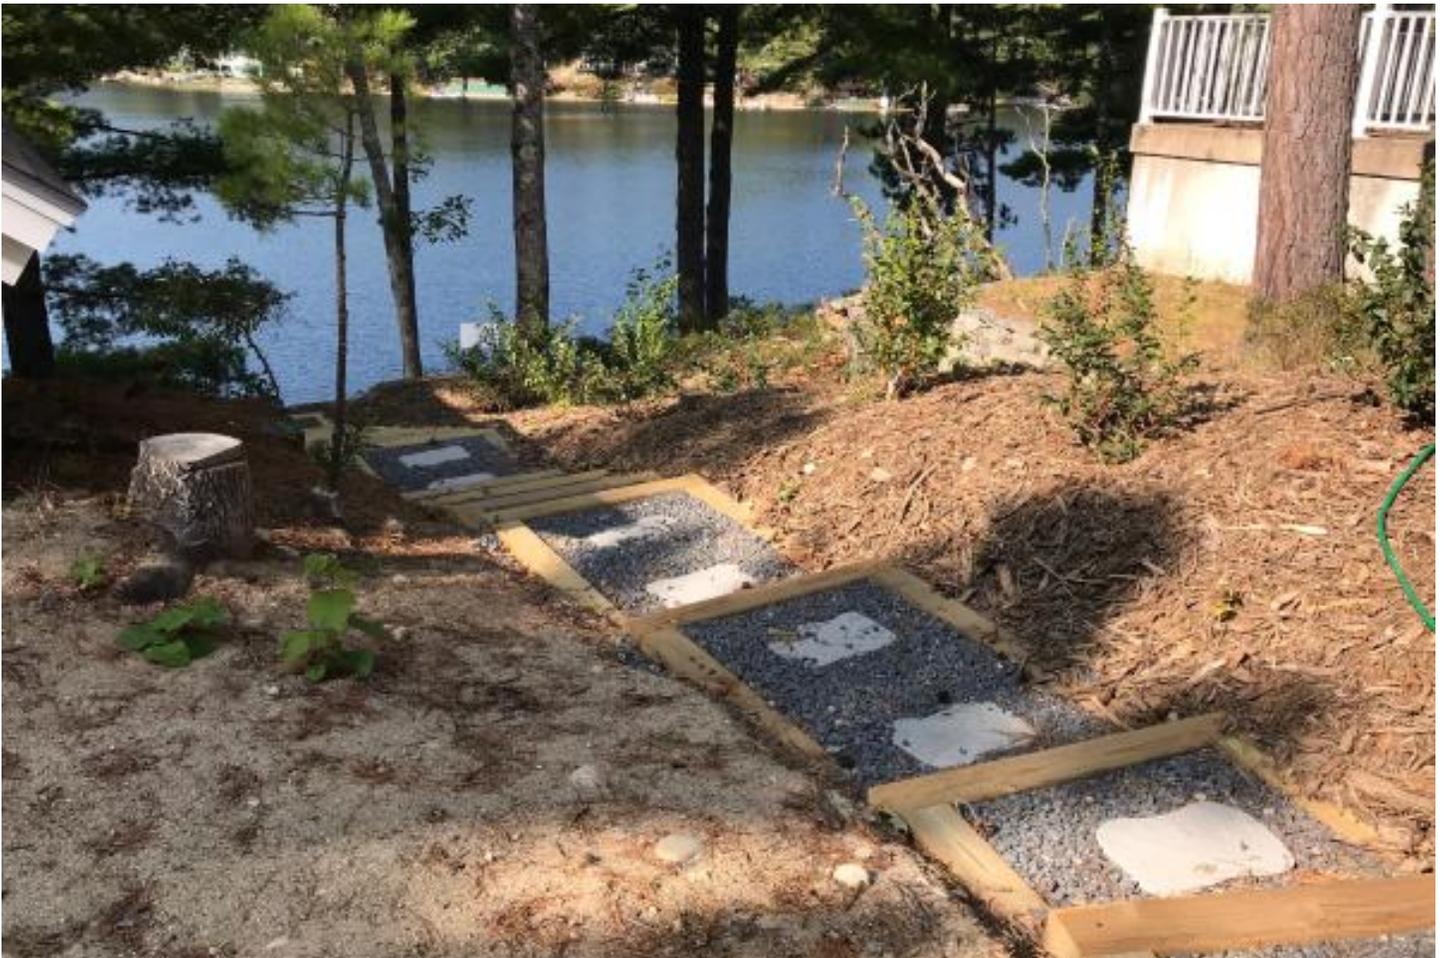
These infiltration steps are filled with crushed stone and lined with geotextile fabric to filter stormwater that flows down. The erosion control mulch and native plants to the side will help slow and filter additional water that bypasses the stairs.

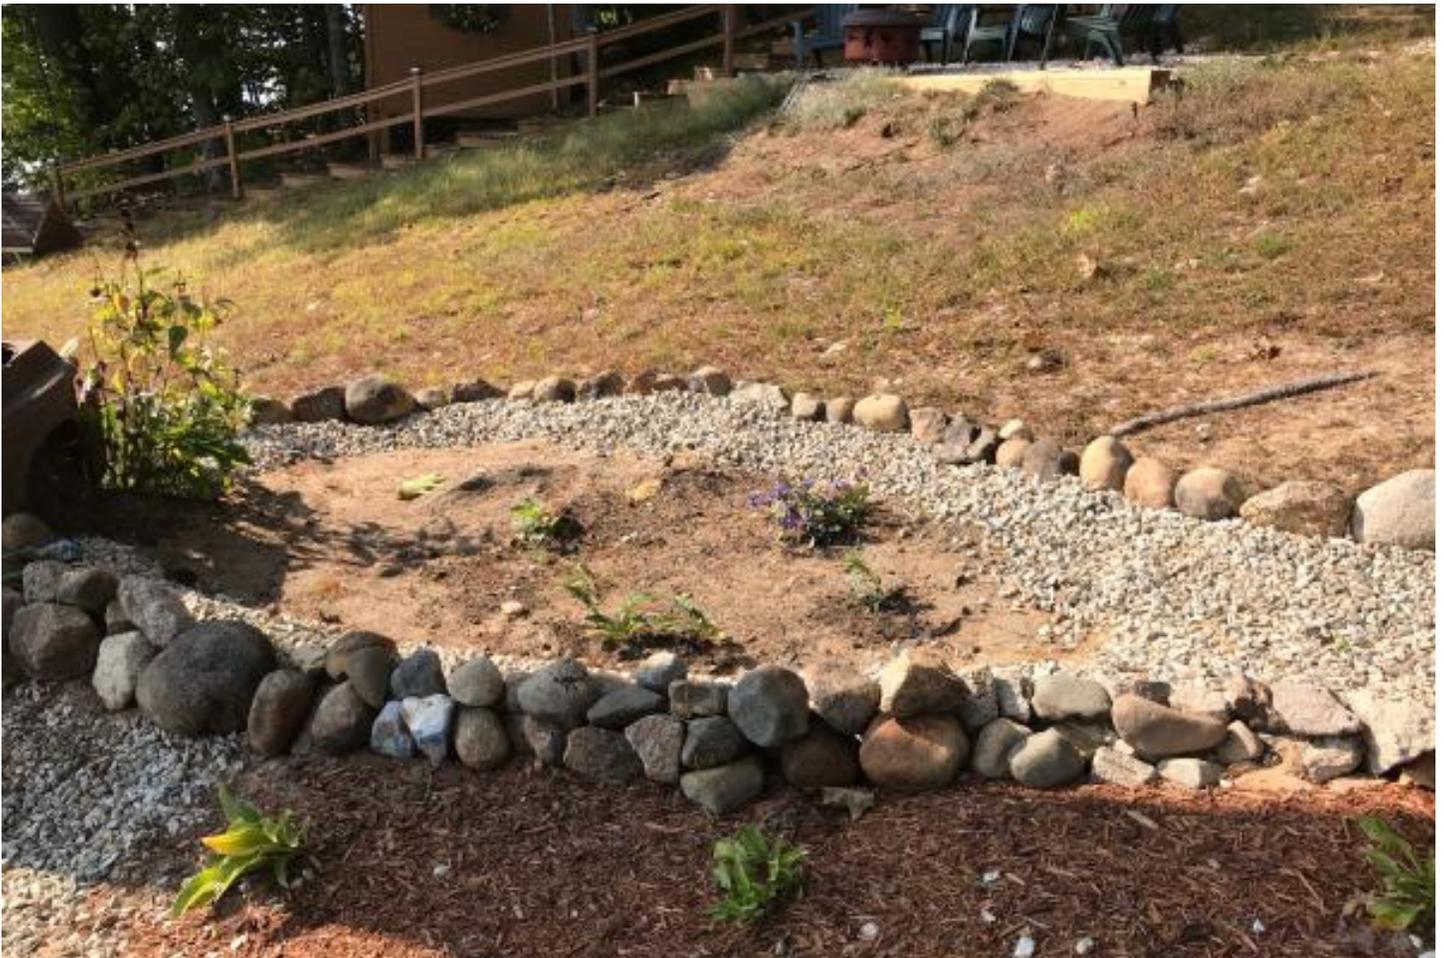
This rain garden creates a depression to capture and filter stormwater and grow beautiful native plants.

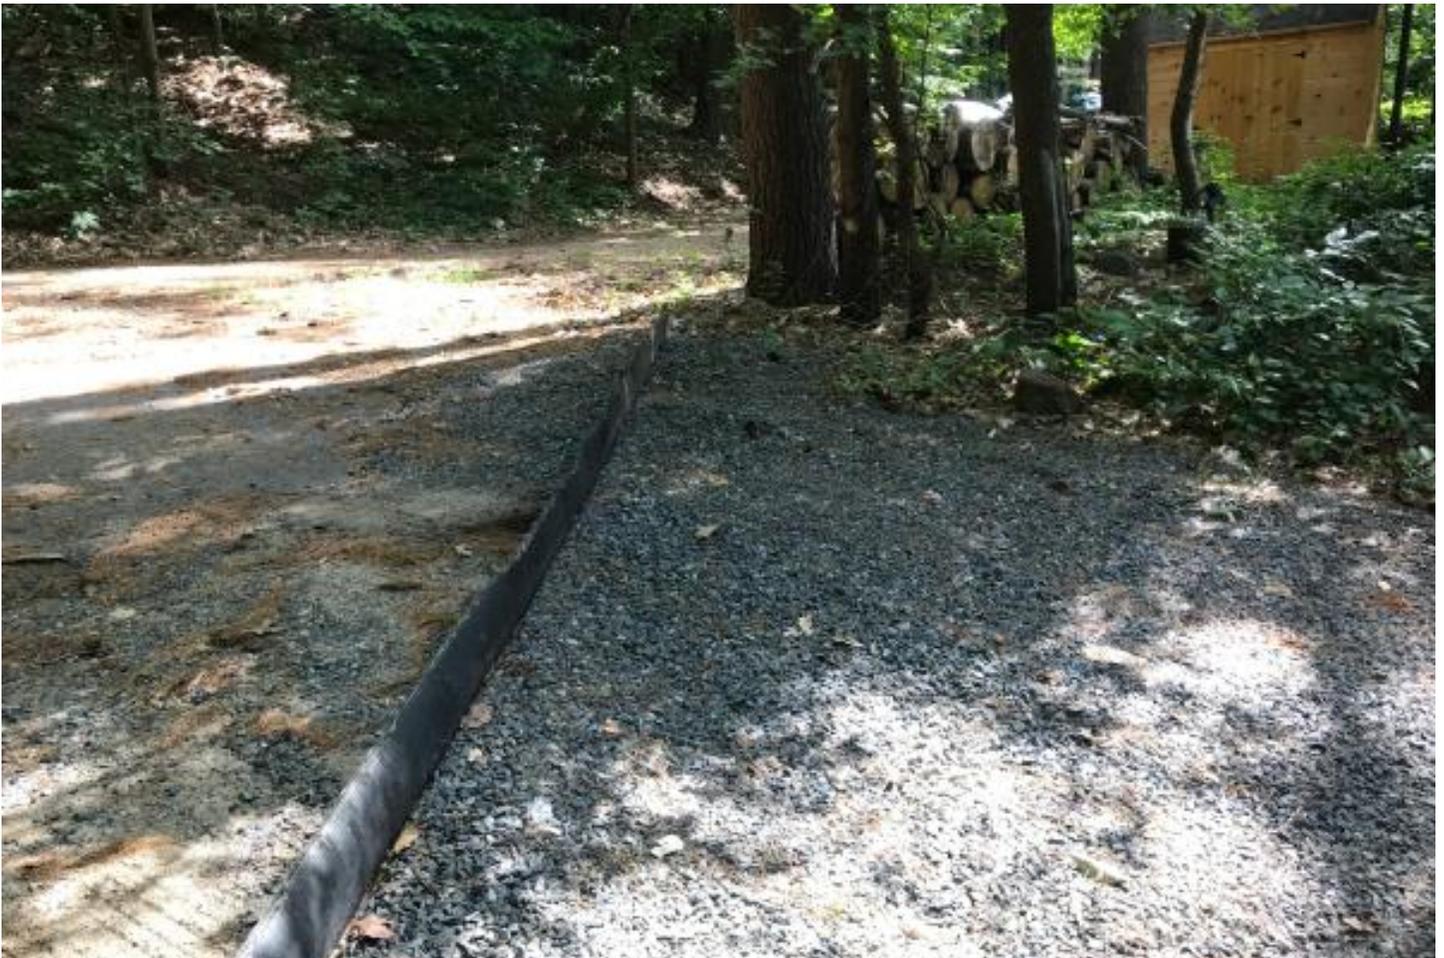
Rubber razors divert water off of camp roads and gravel driveways into more stable and vegetated areas or a dry well.
